# Manhole Inspection Summary

Manhole # S33E\_\_031MH

Insp Date: **10/27/08 12:48 PM**

**Location** Address: **25 w fayette st**

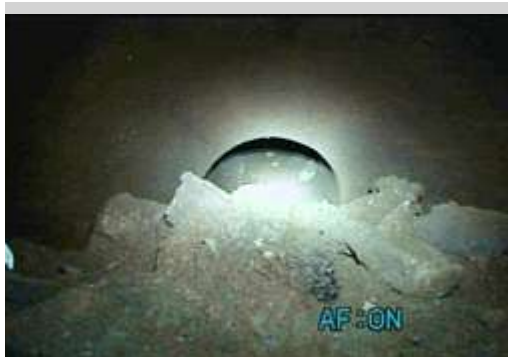
Defect 6

Condition: ☐ Sound ☐ Cracked ☐ Root Intrusion ☐ Deteriorated ☐ Leaks ☒ **Debris**

channel cond debris

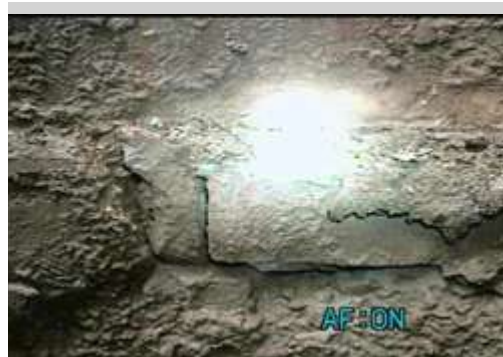
Defect

Condition: ☐ Sound ☐ Cracked ☐ Root Intrusion ☒ **Loose Brick** ☒ **Deteriorated**

deteriorated chimney

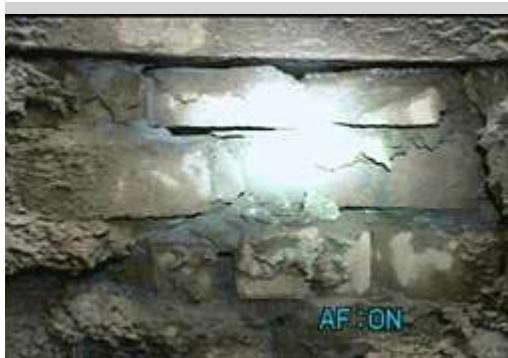
Defect 4

chimney loose bricks

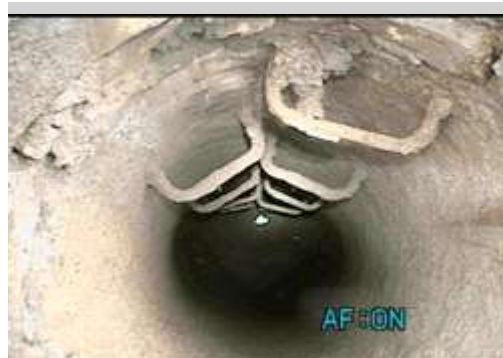
Defect 3

Count: **11** Missing: **0** ☒ **Corroded**

corr steps

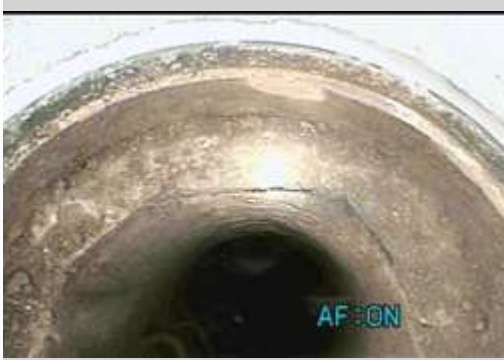
Defect 2

Offset: **5** (in.)

frame offset, chimney cond deteriorated,  
chimney cond loose bricks

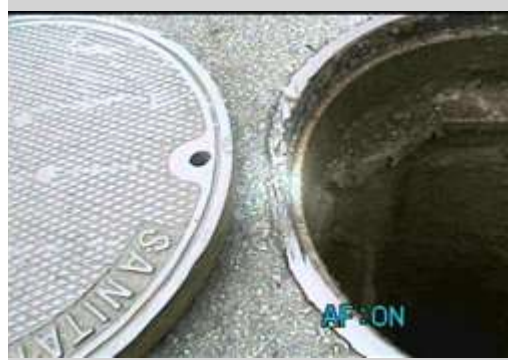
Defect 1

Condition: ☐ Sound ☒ **Cracked** ☐ Leaks

frame cracked

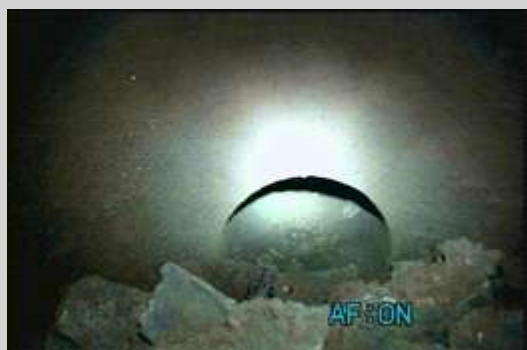
12 O'Clock Outflow

cant get good shot due to debris
